Struvite Strife In Bethlehem

Pennsylvania water treatment plant battles struvite deposits in internal distribution pipe

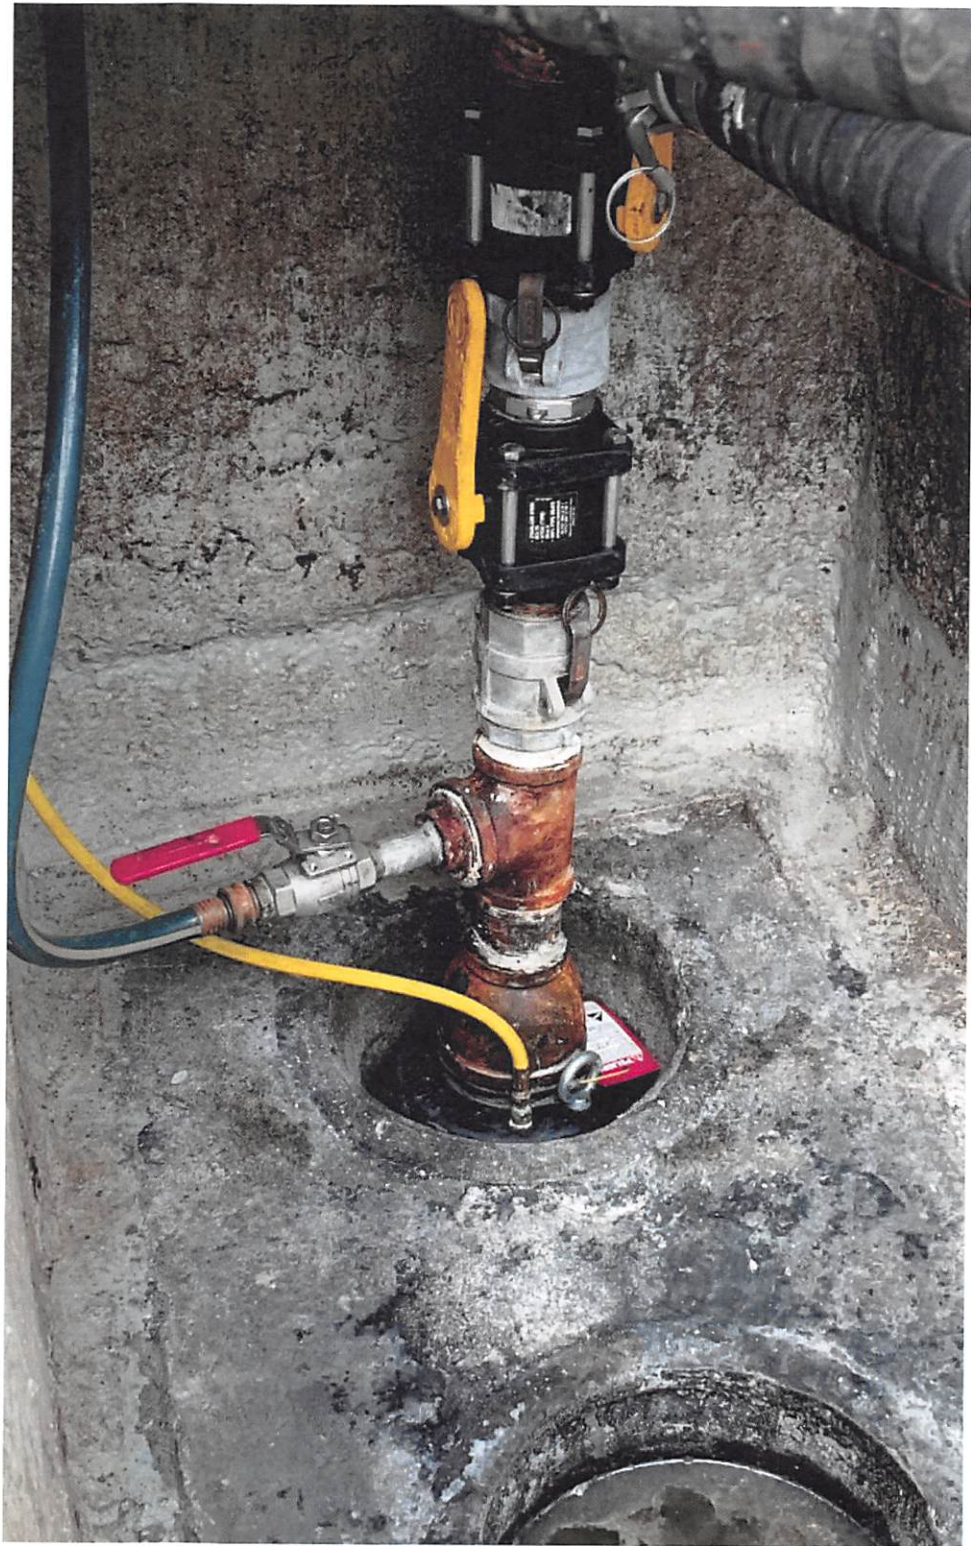
Struvite is a crystalline structure of magnesium, ammonium and phosphate that commonly builds up in pipe networks and is resistant to traditional maintenance methods for removal.

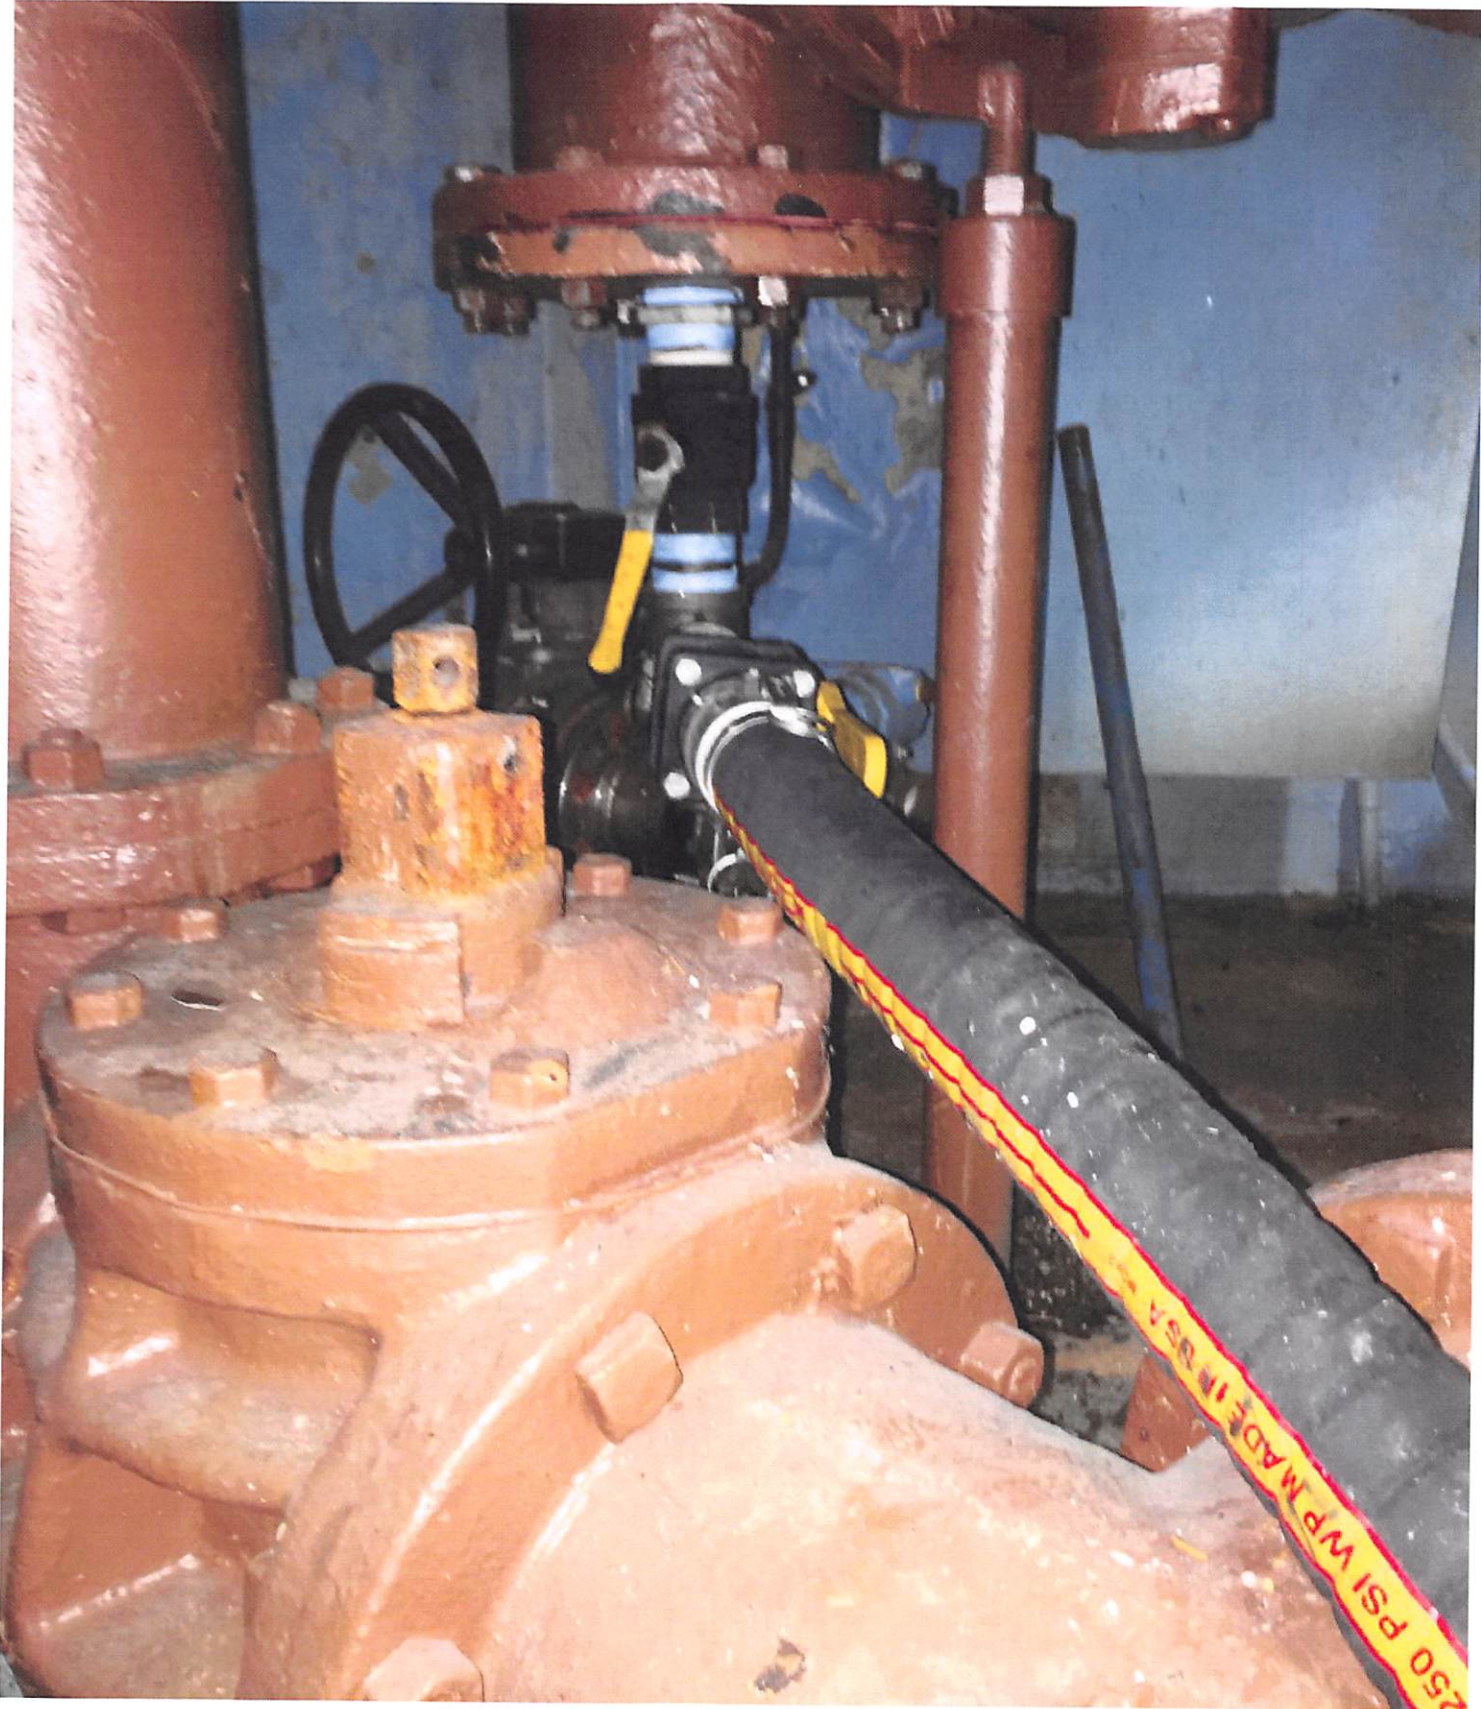
The chemical-based process for removing struvite in pipe has been successful for the Bethlehem Wastewater Treatment Plant's internal distribution lines.

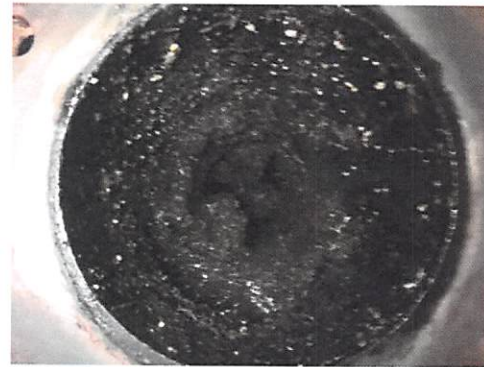
Top: Pipe clogged by struvite.

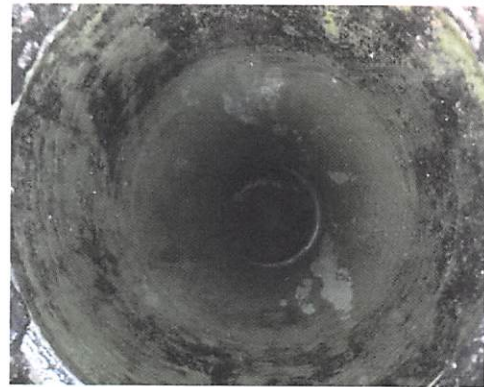
Bottom: Pipe after struvite chemical treatment.

At the end of the project, Bethlehem inspected the pipes and found they were now approximately 99% clean of the struvite. To see the pipe restored to almost new condition so quickly and with little impact on operational efficiency satisfied the WWTP.
