Struvite Dissolver Restores Flow to Fertilizer Operation

Problem: Stubborn struvite buildup clogged facility's solids transport pipe, impeding flow to the fertilizer manufacturing facility.

Solution: Treating the pipes with a struvite dissolver restored their full capacity without compromising fertilizer production or quality.

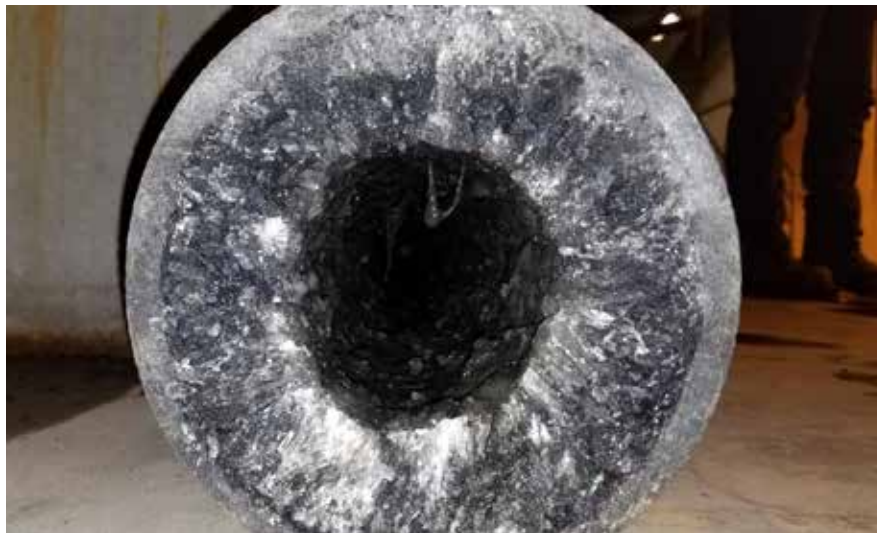
Starting around 2015, Bayville facility operators noticed a slight increase in pumping pressure and a decreased ability to maintain a flow rate of 16 to 17 L/s (250 to 275 gal/min) in two 150-mm (6-in.) pipes used to transport anaerobically digested solids to the fertilizer manufacturing facility, a distance of about 320 m (1050 ft). For the next 5 years, the problem progressed from minor to significant, at which point operators excavated several sections of the underground pipe, discovering that the pipe had become so clogged with struvite that its diameter was reduced to 65 to 80 mm (2.5 to 3 in.).

The Ocean County Utilities Authority (OCUA; Bayville, N.J.) excavated sections of solids transport pipe to discover a massive buildup of struvite.

A common problem in wastewater treatment pipes, struvite accumulates in the presence of magnesium, ammonia, and phosphate and builds up inside pipes and other processing equipment as a hard, cement-like mineral. Operators first tried jetting out the blockage using high-pressure water, but struvite is notoriously stubborn, as was the case in Bayville. Another option was to replace the piping, a massive capital project that would have cost upwards of USD \$1 million, not to mention extended downtime that would affect solids control and fertilizer production. In 2020, OCUA decided to explore a struvite dissolver.

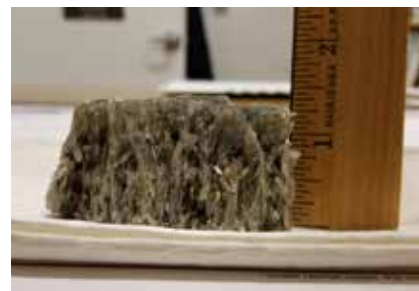
At more than 2.5 cm (1 in.) thick throughout the pipe, the struvite buildup could not be jetted out.

OCUA was able to meet all four of these conditions with a struvite-dissolving product from Grignard (Rahway, N.J.) called Struvicide™. After a successful trial in which the product removed nearly all the struvite in a section of blocked pipe after a 24-hour soak, Bayville decided to proceed with treating both lines.

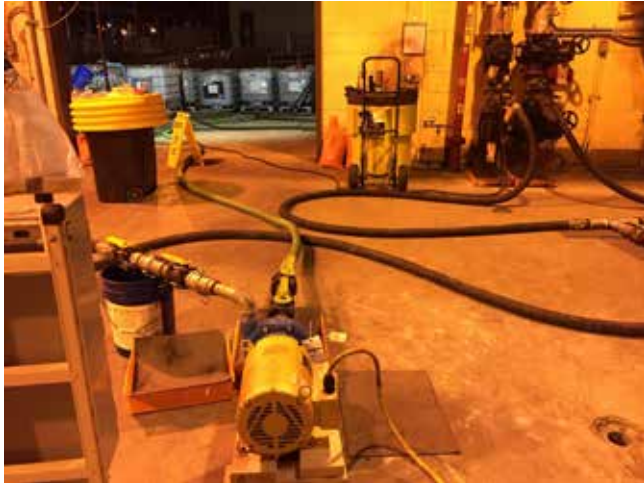
The team let the struvite dissolver soak in the pipes, agitated and recirculated it, then rinsed it out. Pumping pressure and flow rates returned to optimum levels after treatment.

the other. Grignard handled the struvite removal, line cleaning, and removal of the resulting wastewater. The team injected the struvite dissolver, allowed time for soaking, then agitated and recirculated the struvite dissolver for maximum effectiveness. Each line was flushed, rinsed, and returned to service before the facility started up again on Sunday evening.

The product removed virtually every bit of struvite from the two Bayville lines — an estimated 8,238 kg (18,163 lb) — and returned the pipes to their full, 150-mm diameter. Pumping pressure and flow rates returned to optimal levels, ensuring solids treatment and fertilizer production are at full capacity.
